# Safety Inspection Report

Annual Inspection

## Branch End Play Area (Old & New)

Stocksfield Parish Council

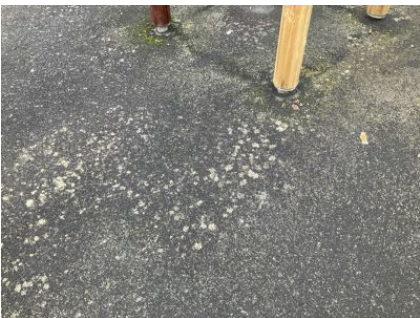
Algae growth giving slippery conditions.

Powerwashing is recommended. Care should be taken to ensure that the material can sustain high pressure washing.

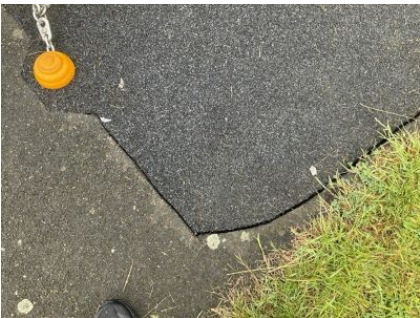
Shrinkage / separation of the surface. This may give a trip hazard.

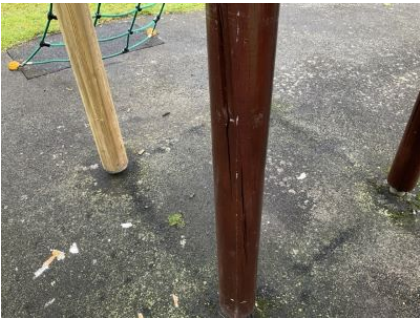
Splits in timber are common. It is not recommended to fill the split, as this may cause decay. Monitor regularly for increased gap, splinters or decay. When net is replaced, please check for internal decay at support beams.

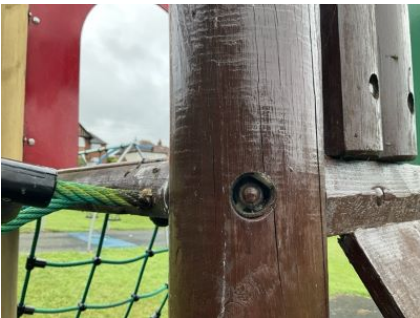
Cap missing.

Replace.

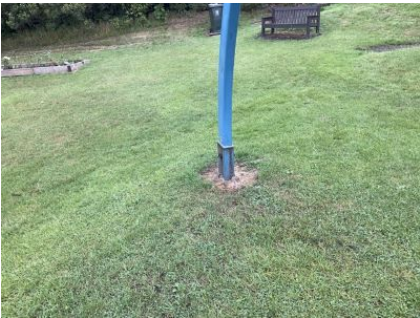
This equipment relies on one post for its stability. Special attention should be paid to maintenance (e.g. by monitoring degradation) and if necessary decommissioning the item before the end of its operating life. This is a requirement of the British Standard.

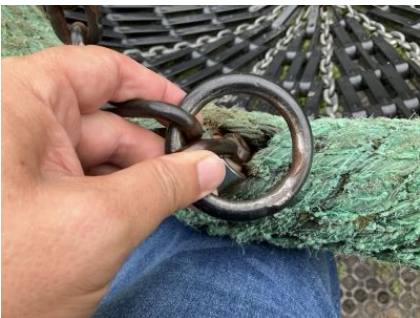
Some chain wear.

Monitor for further deterioration and replace before 40% wear.

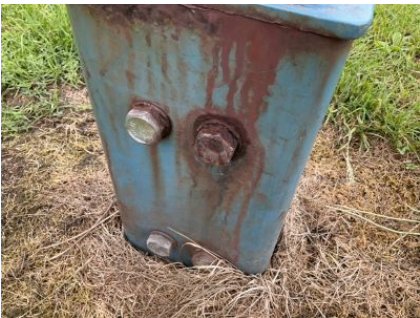
Fittings are rusty.

Replace.

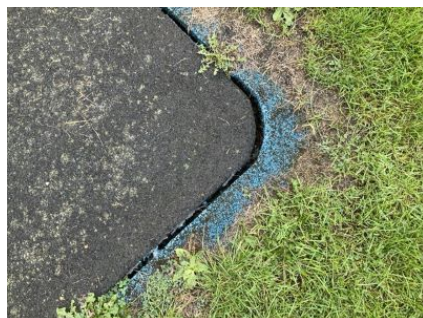
Shrinkage / separation of the surface. This may give a trip hazard.

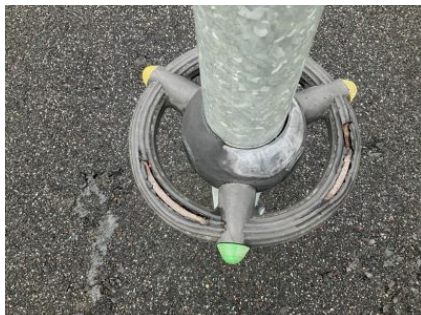
There is wear on the platform.

Exposed metal which is corroding. Monitor and plan for replacement.

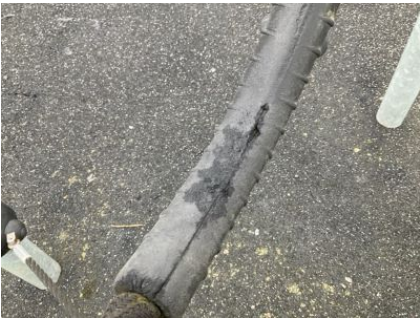
Item is damaged.

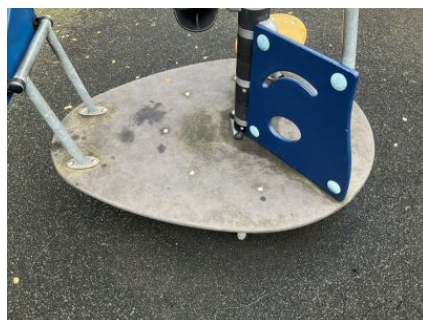
Very difficult to move.

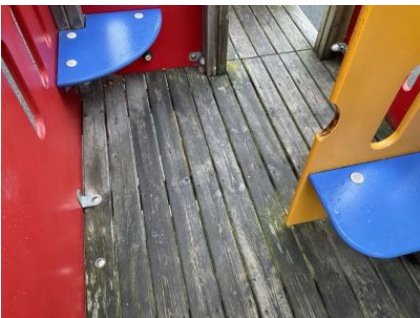
Algae growth giving slippery conditions.

Powerwashing is recommended. Care should be taken to ensure that the material can sustain high pressure washing.

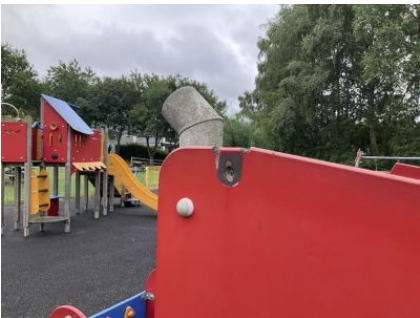
Item has some parts missing.

Replace the missing parts.

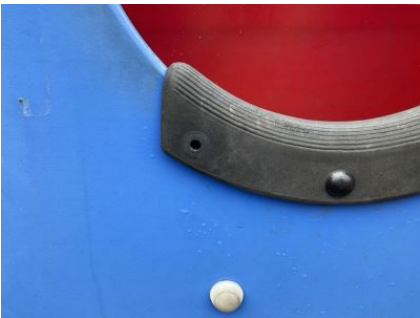
Bolt is missing.

Replace.

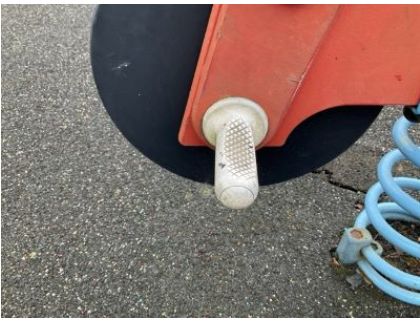
1. The spring is rusty. These have been known to fail without warning, leading to a collapse of the unit.

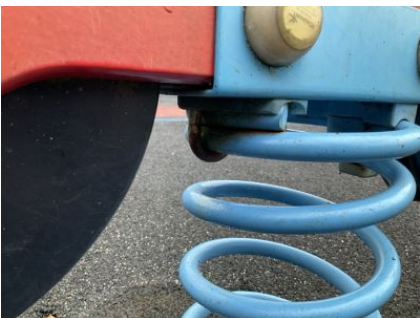
The spring is rusty. These have been known to fail without warning, leading to a collapse of the unit.

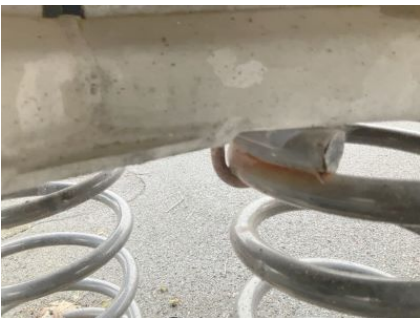
The spring is rusty. These have been known to fail without warning, leading to a collapse of the unit.

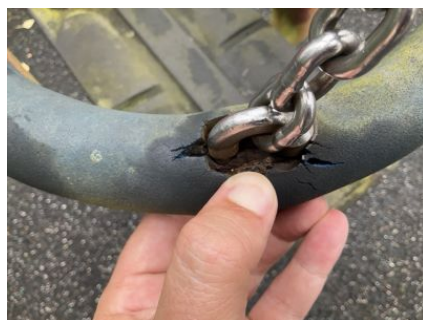
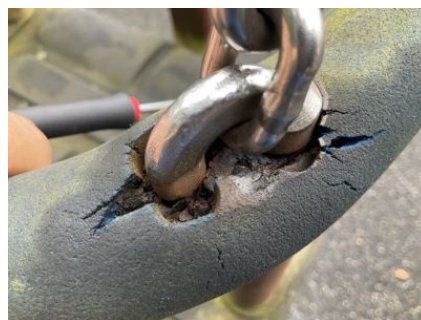
Corrosion in cradle seat top frame could lead to sudden failure of the seat.

Inside crumbling and chain becoming loose.

Replace the seat.

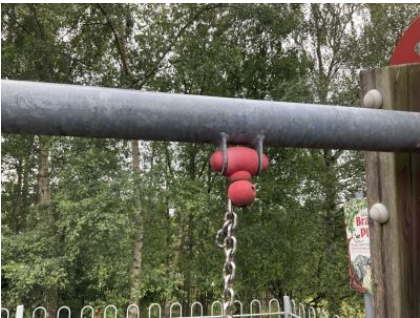
The covers should be removed from the fitting at the top of the chain annually and the shackle bolt should be checked for wear. Check the security of the fittings too.

Replace at 70% of original diameter (30% wear).

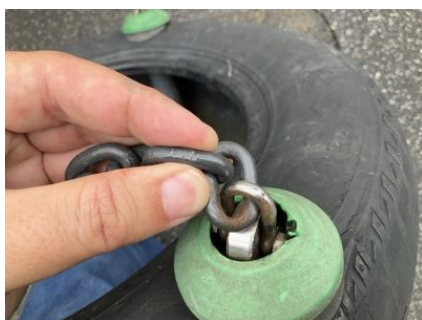
Some chain wear.

Monitor for further deterioration and replace before 40% wear.

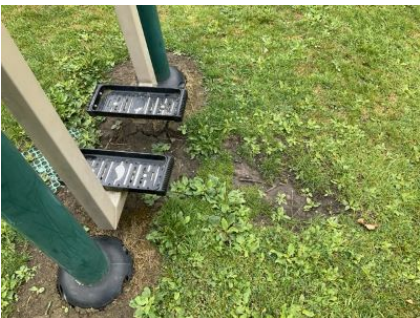
Bolt(s) loose.
