# Safety Inspection Report

Annual Inspection

## Branch End Play Area (Old & New)

Stocksfield Parish Council

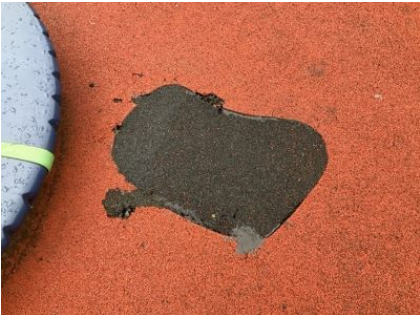
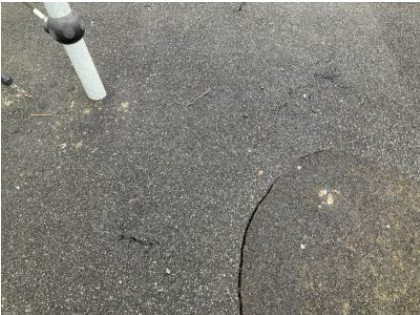
Surface needs repair.

Repair.

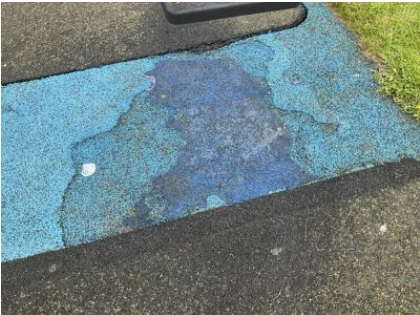
Surface is wearing.

Monitor wear to rubber.

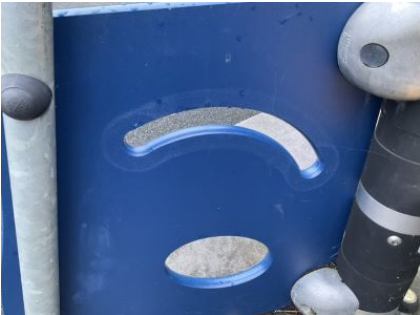
Item has some parts missing.

Replace missing panel feature. Slider?

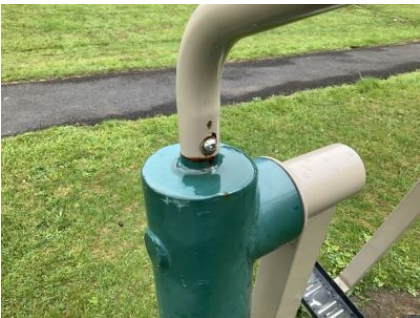
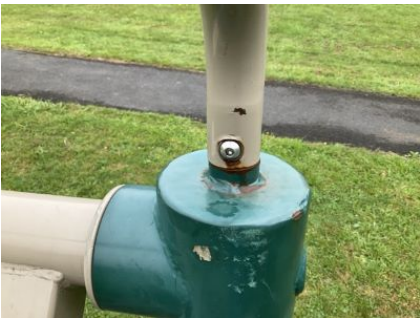
Bolt(s) loose.

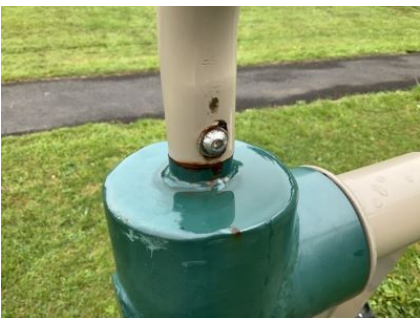
Item is rusting in places.

Repair.
